# Manhole Inspection Summary

Manhole # S23CC1042MH

Insp Date: 7/11/07 9:39 AM

**Location** Address: **1503 UNION AVE**

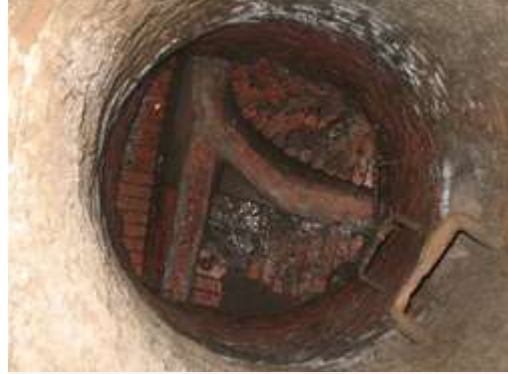
Top View

Corroded and missing steps. Bench debris.

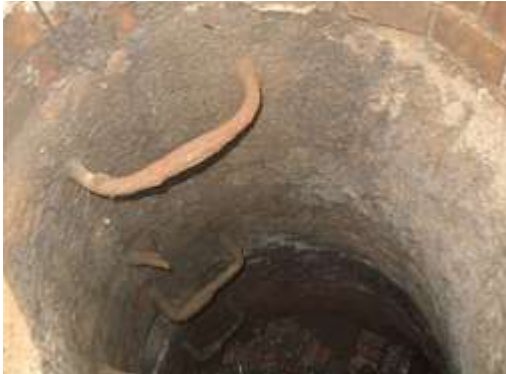
Defect

Adjustment deterioration and infiltration. Corbel and Barrel infiltration.

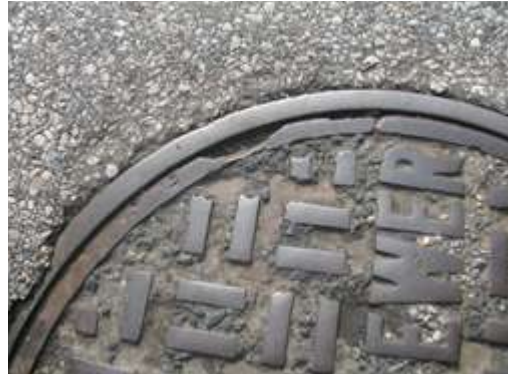
Defect

Chipped lid.

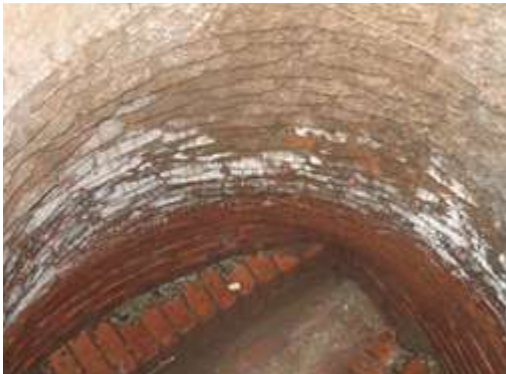
Defect

Adjustment and Corbel infiltration.

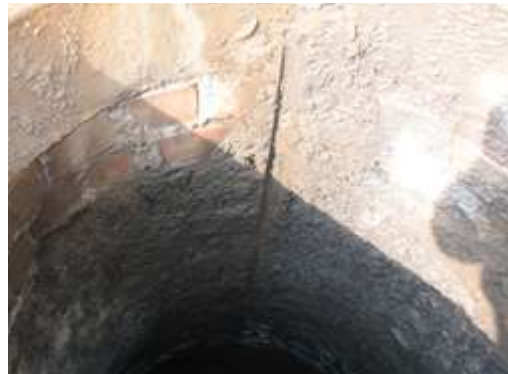
Defect

Frame leaks. Adjustment deterioration and infiltration. Corbel infiltration.

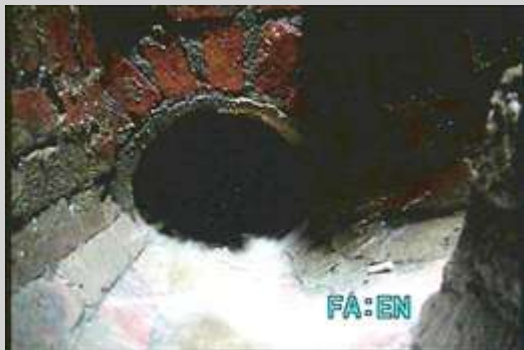
### 10 in. Circular Gravity Sewer Pipe Out @ 12 O'Clock

Infiltration: **Evidence** Pipe Seal Cond: **Cracked**

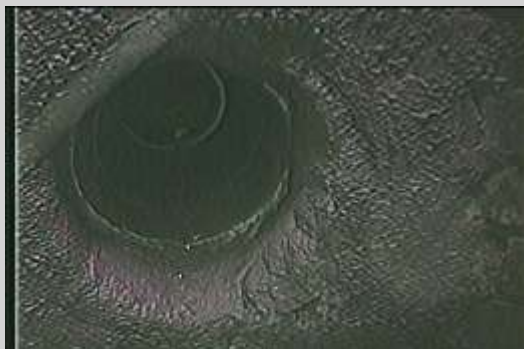
### 8 in. Circular Gravity Sewer Pipe In @ 3 O'Clock

Infiltration: **Evidence** Pipe Seal Cond: **Broken**
